NANTUCKET EELGRASS MAPPING PROJECT
SUMMER 2015

Final Project Report

Nantucket Natural Resources Department
2 Bathing Beach Road
Nantucket, MA 02554

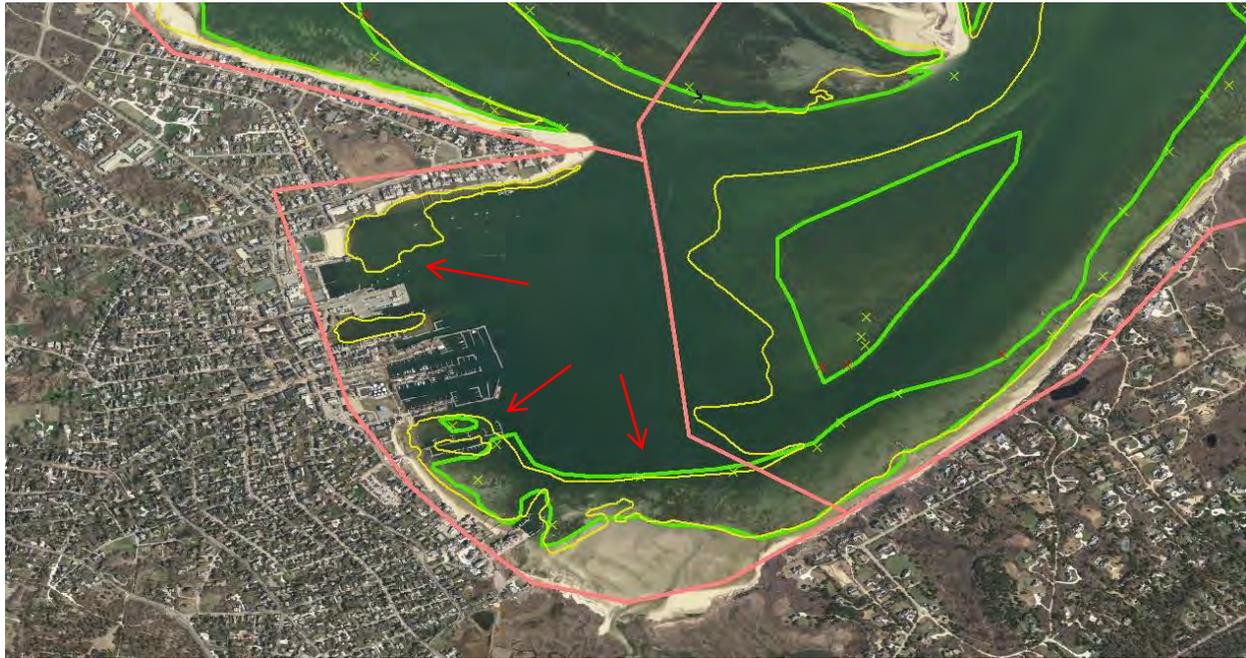
Region 1, Downtown

Eelgrass Area Acres	<u>1995</u>	<u>2015</u>	<u>20yr % Change</u>	<u>Ave.% Decline/yr</u>
	50.1	35.2	-30%	-1.5%

This area of the Harbor has experienced the largest decline in eelgrass. Most notably the polygon in vicinity of Steamship Authority terminal north to the Town boat ramp and along the shore to the Coast Guard Station disappeared between 1995 and 2001. It could be expected that water quality issues related to point and non-point sources contributed to this rapid loss of habitat.

A similar change occurred in the Town Marina area. This area could have been stressed with water quality stresses coming from the adjoining watershed and also the impacts from the busy marina (fuel spillage and mechanical disturbance from prop-wash).

The relatively stable outer eelgrass boundaries in the area East of the Great Harbor Yacht Club Complex which enjoys a relatively undeveloped to sparsely developed watershed appears to have maintained its health. The eelgrass resources in this area should be surveyed carefully to detect future changes resulting from increased boat traffic from the Yacht Club.

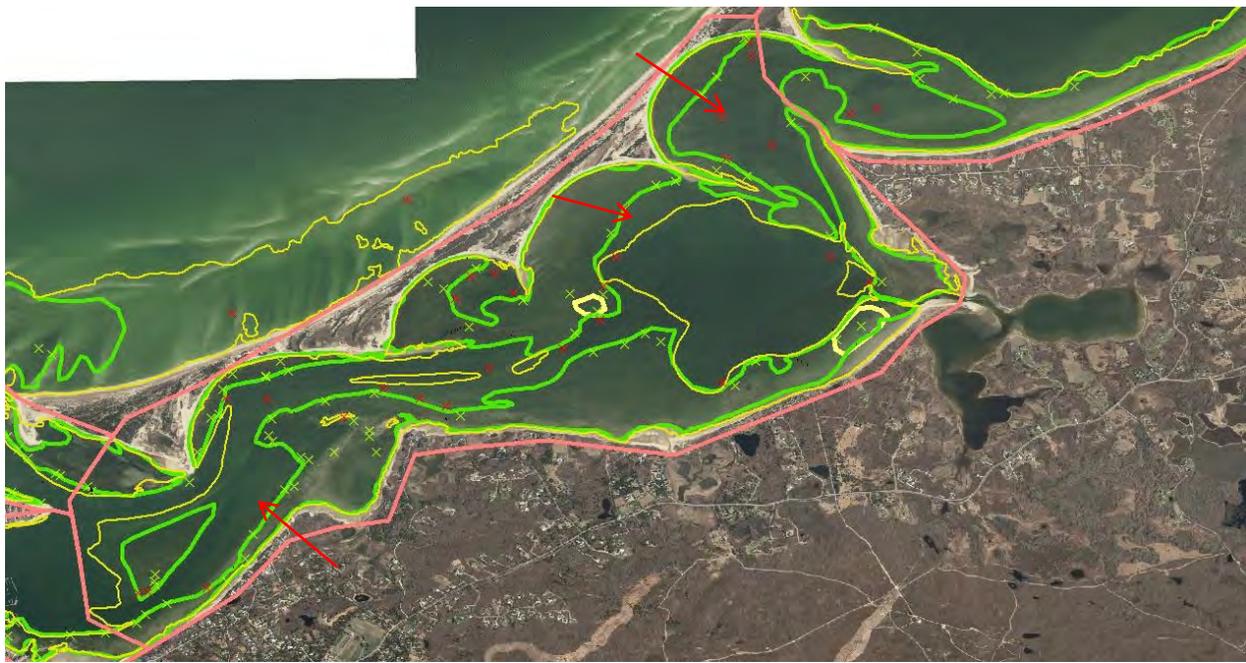
REGION 2, First to Fourth Point

Eelgrass Area Acres	1995	2015	20yr % Change	Ave.% Decline/yr
	1486.5	1024.9	-30%	-1.5%

This region has also experienced significant decline over the 20 year period. Loss is seen in the western most red arrow in the deeper and shallower areas. Declines to the outer edges in region of third Point and Pocomo are indicative of lower amounts the sun’s energy reaching the deeper plants.

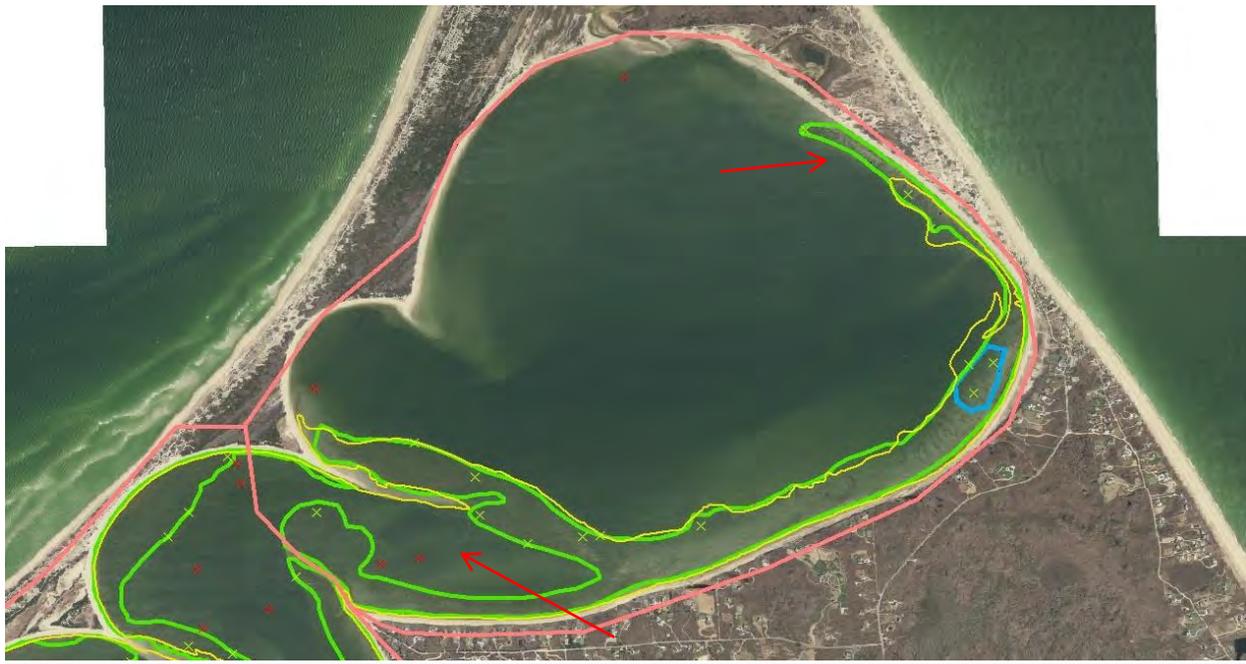
REGION 3, Head of Harbor

Eelgrass Area Acres	<u>1995</u>	<u>2015</u>	<u>20yr % Change</u>	<u>Ave.% Decline/yr</u>
	380.8	291.7	-24%	-1.2%

This region has experienced decline in the deeper water East of Pocomo. The remaining linear eelgrass has remained relatively stable with a small increase in the polygon to the far East. The blue polygon shown here is one of three areas where hydrocoleum/lyngbya was mapped. This will be described in a later section of this report.

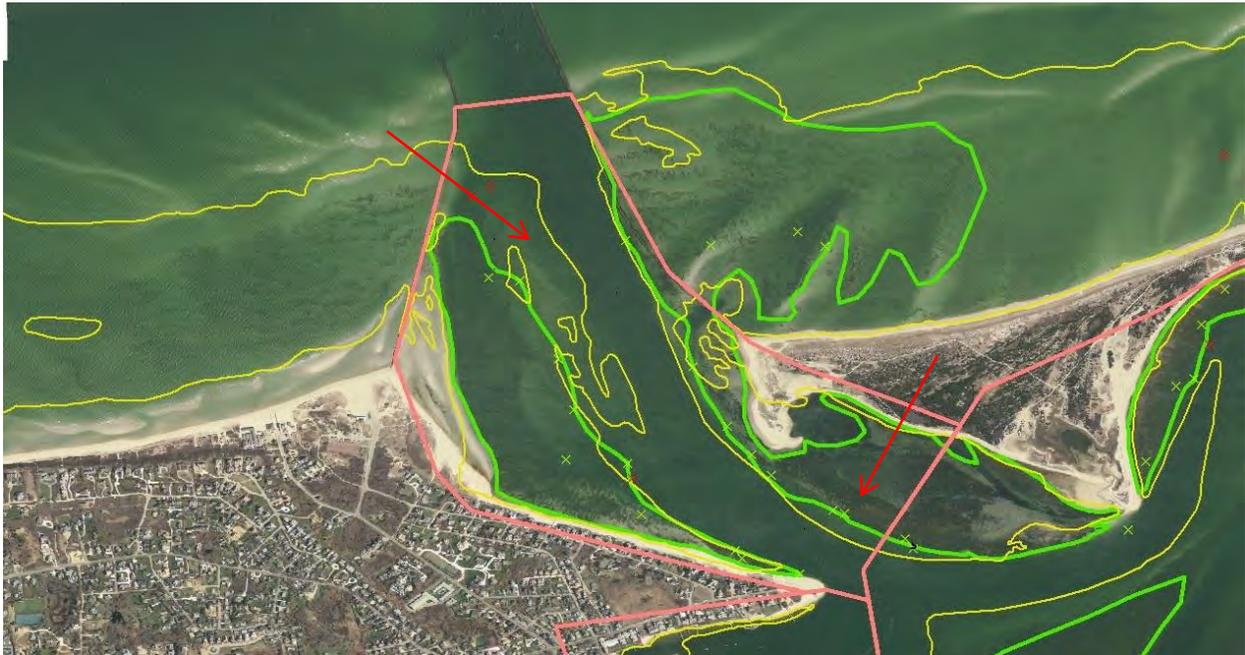
Region 4, Harbor Entrance

Eelgrass Area Acres	1995	2015	20yr % Change	Ave.% Decline/yr
	202.0	133.7	-32%	-1.6%

This Harbor Entrance Area has also declined at the same rate as the earlier areas. As this area is well-flushed with tidal flow it could be assumed that water quality (turbidity) is not the reason. The area along the Western Jetty has declined significantly along its deep edge. This could possibly be to winter storm events that have very severely reduced the eelgrass resources on the shoreline directly facing the wave action from the North (these coastal areas are not included in this report).

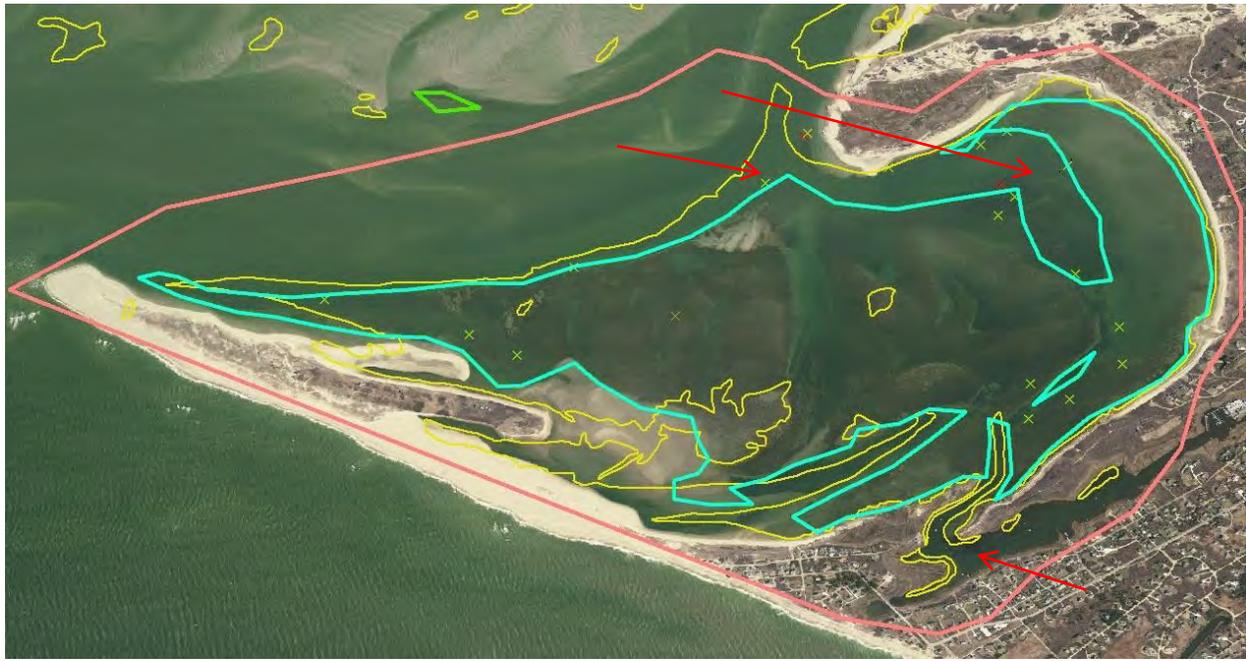
Region 5, Madaket

Eelgrass Area Acres	<u>1995</u>	<u>2015</u>	<u>20yr % Change</u>	<u>Ave.% Decline/yr</u>
	673.3	513.3	-24%	-1.2%

Madaket has declined along the deeper edges South of Eel Point possibly due to storm and tidal current action. Declines were noted in the deeper channel area on the outer edges of the polygons. A complete loss of habitat in the inner Madaket Harbor area on both sides of the channel and in the upper reaches of the inner harbor. Water quality issues could be suspected in these losses as the contributing watershed seems to have experienced increased development during this period.

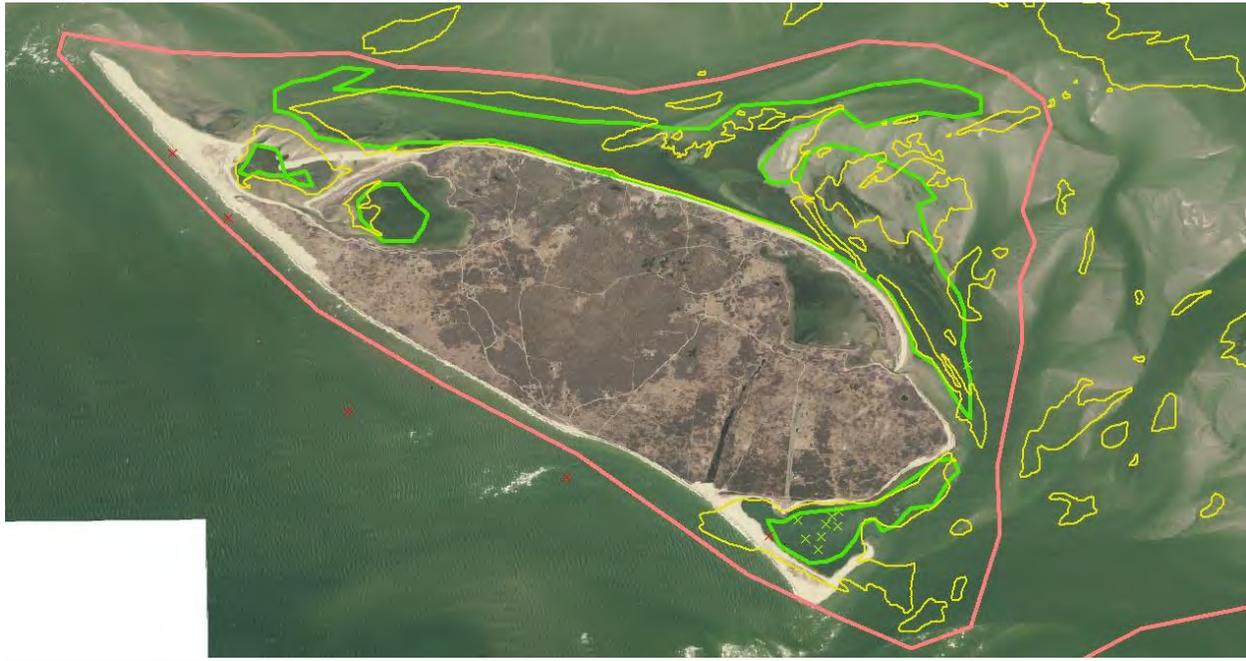
Region 6, Tuckernuck

Eelgrass Area Acres	<u>1995</u>	<u>2015</u>	<u>20yr % Change</u>	<u>Ave.% Decline/yr</u>
	388	391	+0.08%	-----

The Tuckernuck Region has been relatively stable during this 20 year period. Tidal action and storm events have understandably altered the eelgrass beds in the sandy shoal areas between this island and Madaket. This is the only area of Nantucket to have increased its eelgrass area during this time.

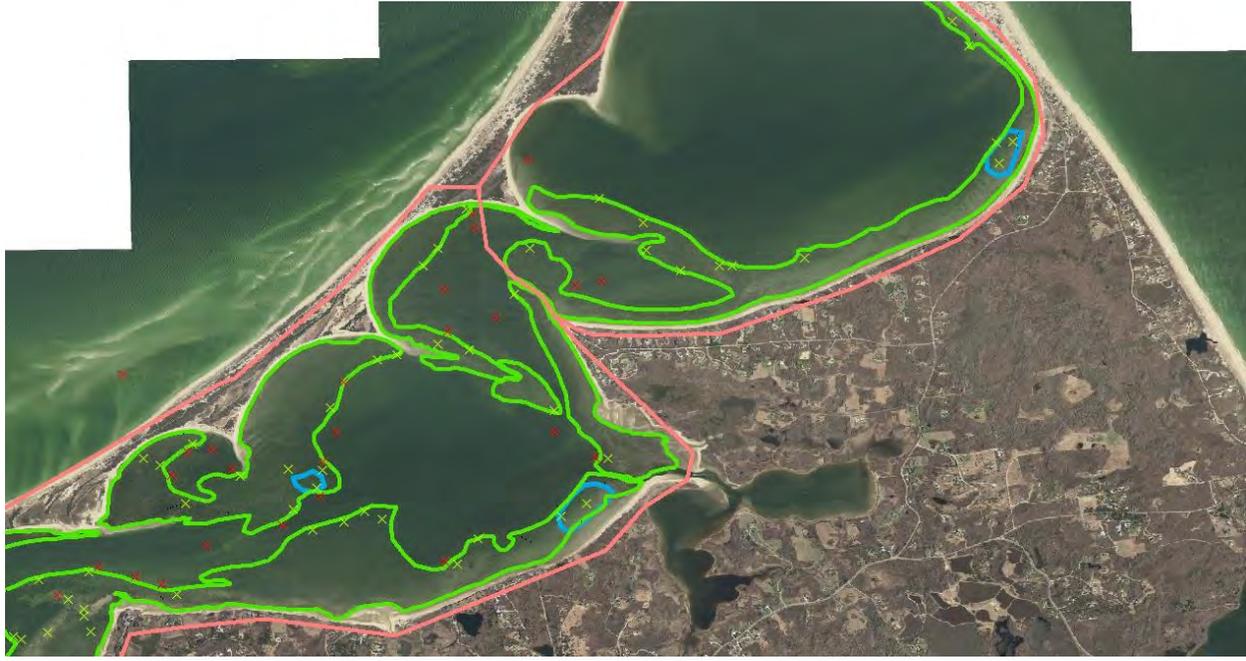
Lyngbya Section

Lyngbya, a black filamentous algae found in many warm water embayments throughout the world, has appeared in three locations in Nantucket Harbor during our summer 2015 survey. Recent research work has determined the cyanobacterium formerly termed lyngbya to be hydrocoleum spp. Fortunately, at this time it is isolated to these sites as shown on the map above. Hydrocoleum/Lyngbya appears when there are high nutrient levels in the water stemming from lawn fertilizers, road runoff, storm water runoff and other types of pollution created by increased development near water bodies. The appearance of the Nantucket hydrocoleum is the first to be recorded in Massachusetts. An active method to stop it would be to aggressively curtail unnecessary overuse of lawn fertilizers and farming chemicals. Hydrocoleum growth can be stopped by starving it of the diet in needs. Recent investigations on the Nantucket hydrocoleum by Pia Moisaider of University of Massachusetts - Dartmouth, has indicated a link to land-source phosphorous and the ability of the algae to utilize excess nitrogen in the Harbor.

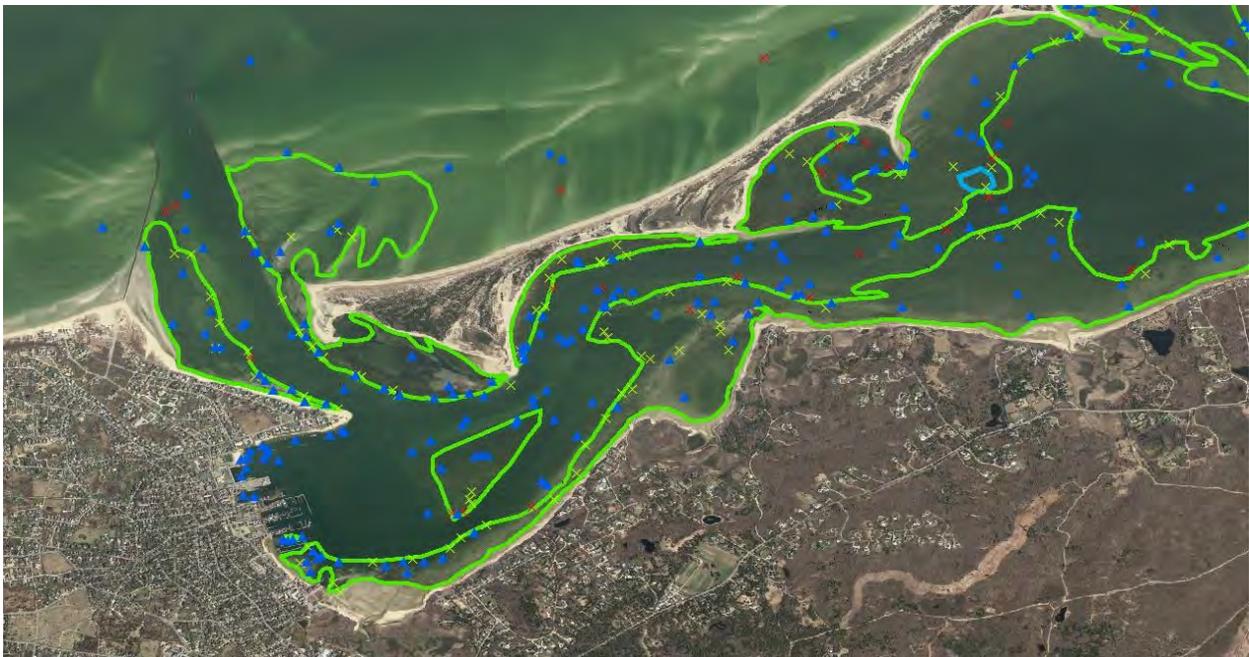
Figure 3

SAMPLE DATA POINT MAP

POINTS 1995 – 2015
